# The Shipwreck (Navagio) of Zakynthos: Decay & Preservation. A First Approach

Adamantia Panagopoulou<sup>1,2\*</sup>, Christos Karydis<sup>3</sup>, Maria Bratitsi<sup>4</sup>, Nikolaos Salamouris<sup>3</sup>, Adamantia Kampiotsi<sup>3</sup>, Georgia Platipodi<sup>3</sup> and Katerina Kabassi<sup>3</sup>

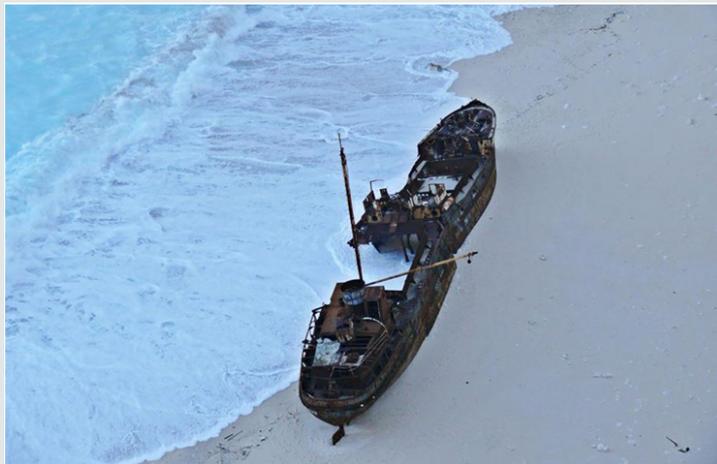
Strong or weak Northwest winds and falling temperatures in the winter months, as well as increased temperature (over 36°C) and humidity levels (over 68%) during the summer and winter months, create a further instability in the preservation of both inorganic (metal, paints) and organic (wood) exposed construction materials of the Shipwreck. During winter the ship suffers from mechanical & chemical decay coming from the sand, salts, and water (Figure 7). The strong north-west winds and the wave accelerate the deterioration of the metal surface. Furthermore, the sea salt -spray increase the chemical decay with the metal parts but also with the remain paints (pigments) where they have been applied to the outer shell of the ship. Furthermore, mechanical decay is also caused from the everyday vandalism of the tourists (scratches, paints, stickers, sprays, etc.), (Figure 8) during the summer period and also the entrance of many tourists inside the ship. The recommendation is if it is possible in the future to measure continuously the RH levels and the UV radiation which the ship is exposed giving further information for the future level of the deterioration.

Figure 7: The Navagio during the winter period (Photo by D. Lykogiannis).

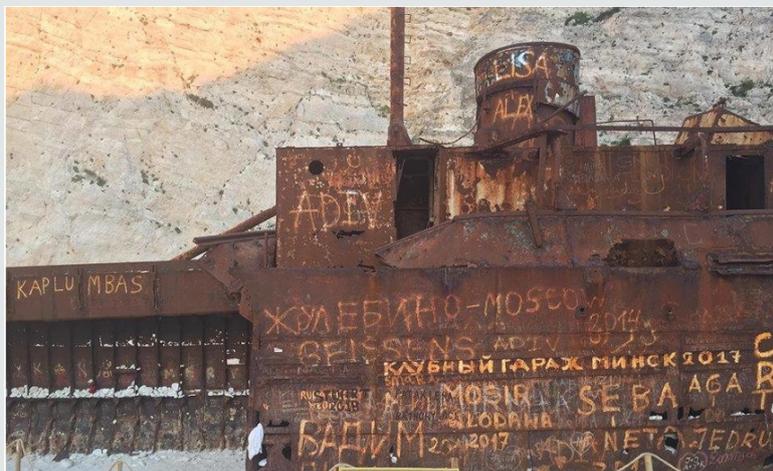
Figure 8: Vandalisms caused by the tourists on the surface of the ship mainly during the summer period.

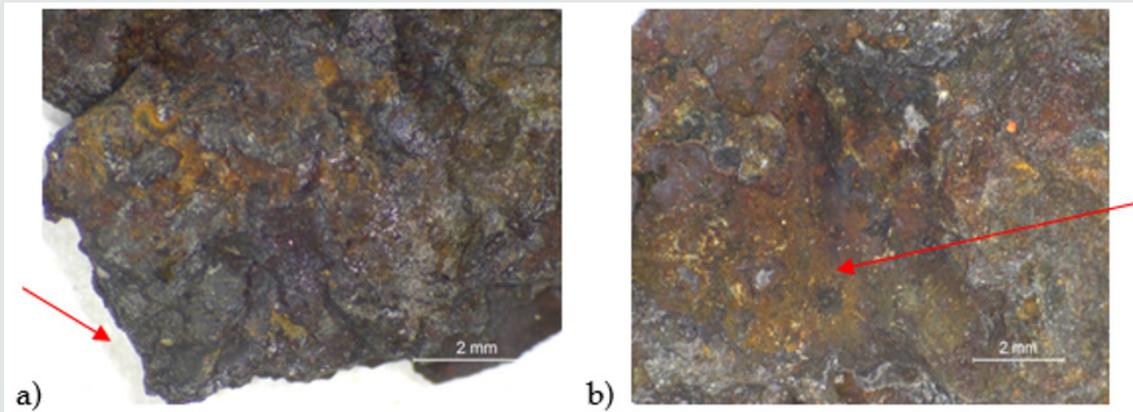
- a) spalling.
- b) cracks, powdered slag.
- c) loose slag flakes around the object.
- d) red-brown corrosion products at loosen points.
- e) tears (drops) on the surface of the object (Figures 9 & 10).

Figure 9: a) Spalling, b) red-brown corrosion products on the metallic surface.

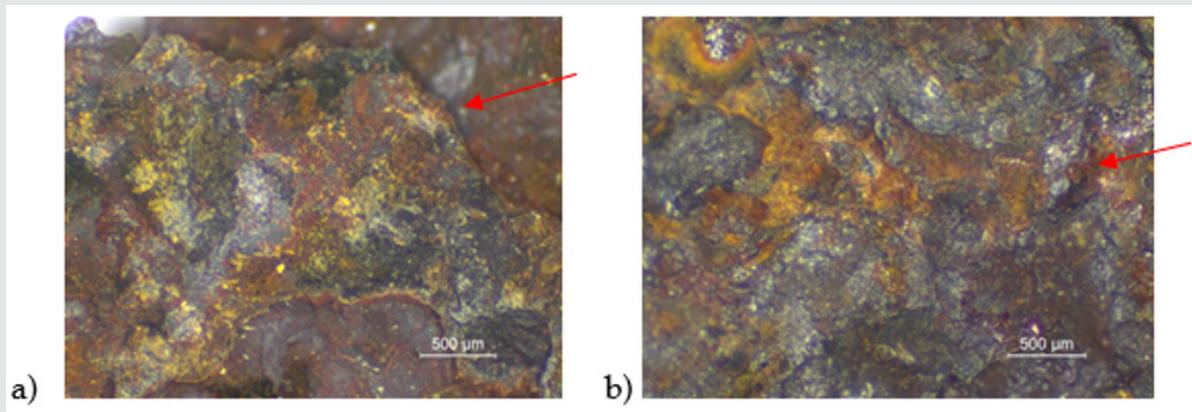
Figure 10: a) Loosen slag flakes around the object, b) tears (drops) on the surface of the object.

On the surface of the ship is observed Iron that “tears” which is a visible symptom indicating that a corrosion process occurs in this iron object. The “tear” is due to the hygroscopic nature of the iron chloride salts.  $\text{FeCl}_2$  crystals are formed under the following conditions:

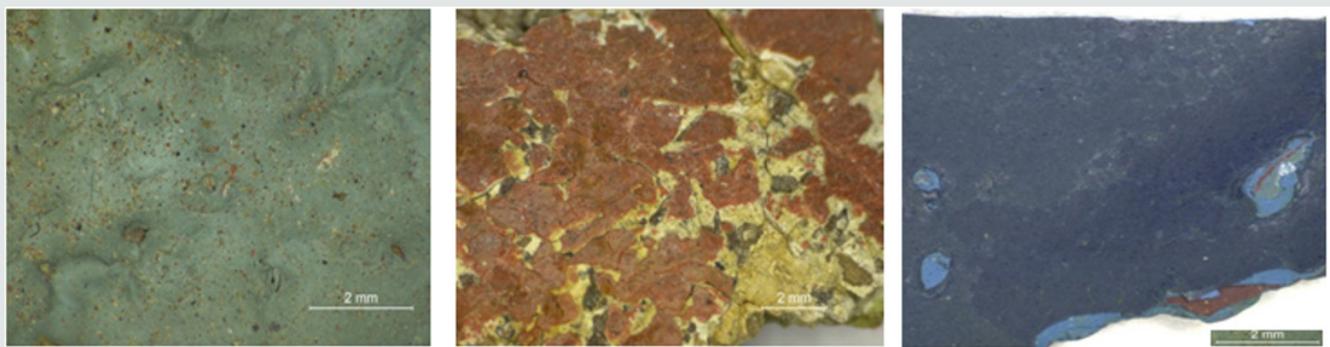
Furthermore, Akaganeite is formed by the presence of high concentrations of chlorine ions and only when the iron object is exposed to the air. Its presence indicates that the object is heavily contaminated with chlorides. Red-brown corrosion products at points of surface rupture are usually Akaganeite ( $\beta\text{-FeOOH}$ ). It is a specific type of oxide with a structure stabilized by chlorides. Furthermore, up to the external corroded layer, some areas of pigments with green, red, blue and light blue colors are totally corroded [9-11],(Figure 11).

Figure 11: The corrosion levels of the pigments on the metallic surface using Optical Microscopy.

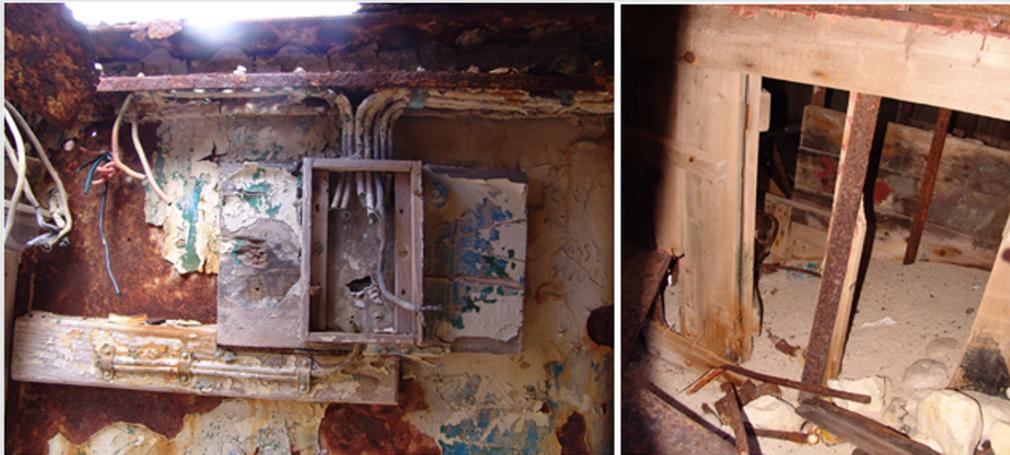
Only a very few parts compared to its total volume (Figure 12), like the planks as a floor on the bridge, the lower parts of the deck's metal floors as a support to the beams and the rudder on the bow outside of the ship are made of wood (Figure 13A&B).

Figure 12: Details of decayed wooden parts inside the ship.

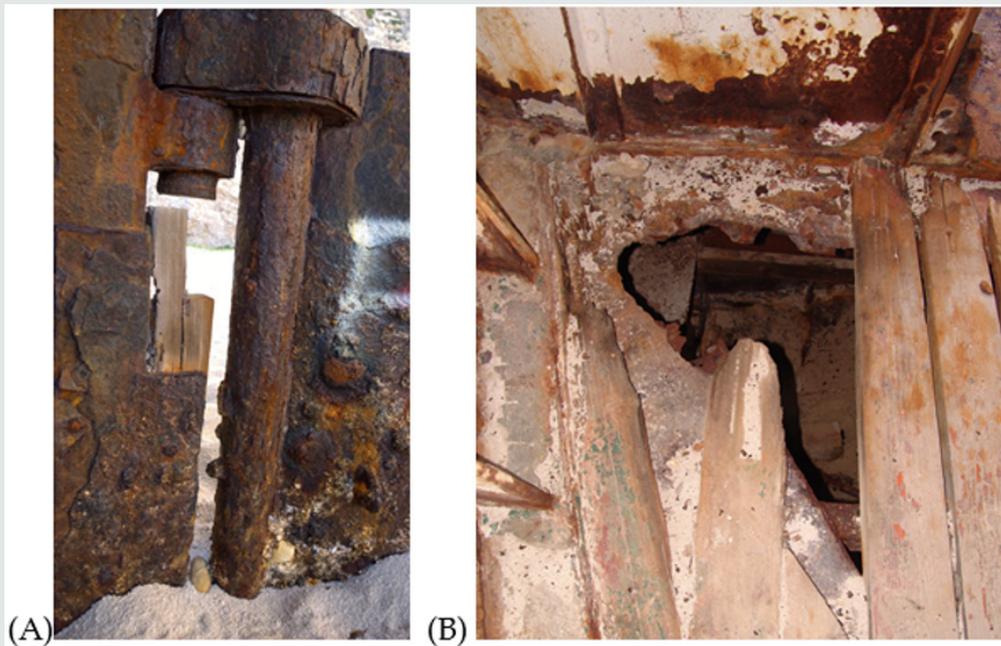
Figure 13: (A) Details from the wooden remains of the rudder on the bow outside of the ship and (B) the floor on the bridge.

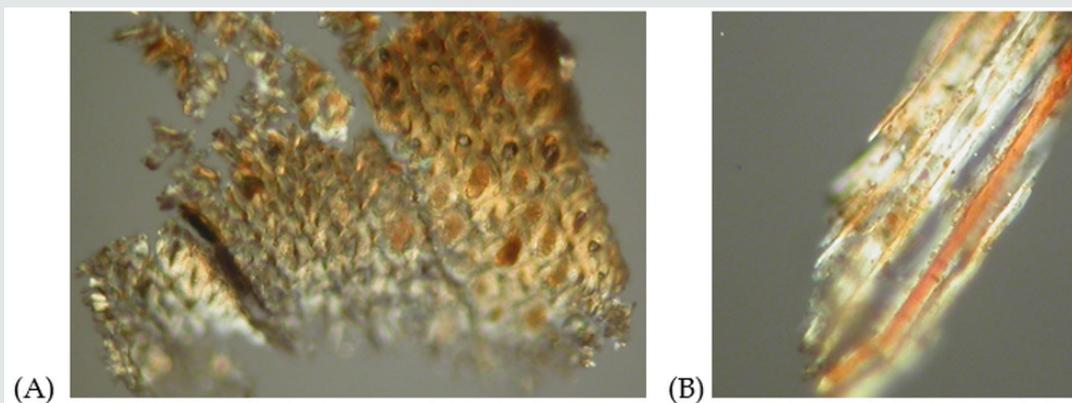
by a very small piece of wood that was lying by the ship and was observed via a polarized microscope (Nikon® E200 - 100X). The transversal section (Figure 14A) is compact and without vessels, a definite indication of Coniferous wood. Large resins canals with thin-walled epithelial cells, shown at the tangential section (Figure 14B) probably indicate a pine tree, although the piece of wood was quite moldy.

**Figure 14:** Microscopic (magnification of 100x) Cellular Structure of (A) transversal and (B) tangential section of wood.

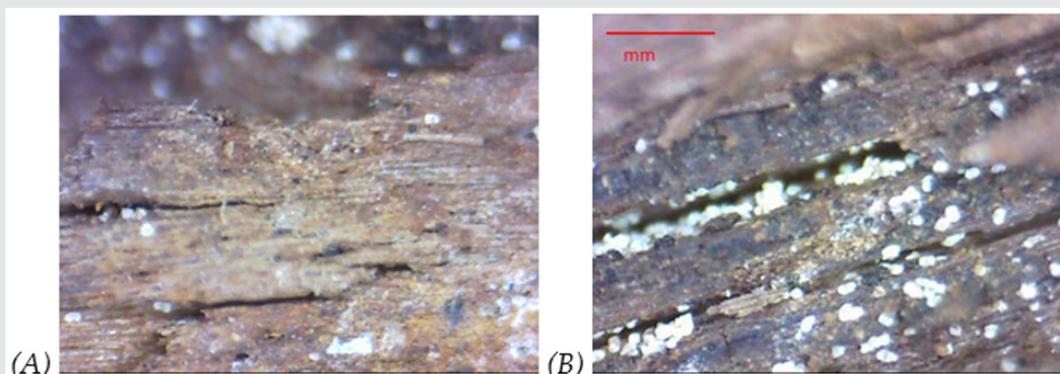
**Figure 15:** A) microscopic observation (via a DigiMicro USB Microscope 1.3Mpix- 200X) of wood showing A) cracks and B) splits with salt and corrosion products.

The problem of wood degradation due to marine organisms [13], occurs when the water recedes in the summer months, as sufficient oxygen allows them to survive and retreat to the wood. These are the fungi that are usually above the waterline (Figure 14B), while worms that attack mainly the sunken wood do not cause damage as the ship is exposed beyond a marine environment for longer time. Contaminants that form suspended particles, sulfur dioxide, nitrogen, ozone, hydrogen sulfide, chlorides cause degradation of wood fibers, reduce mechanical strength, and chemical erosion. Wind action carries sand grains whose friction and impact cause erosion and aesthetic pollution (Figure 15A). Salts from the sea cause separation of wood fibers (Figure 15B).

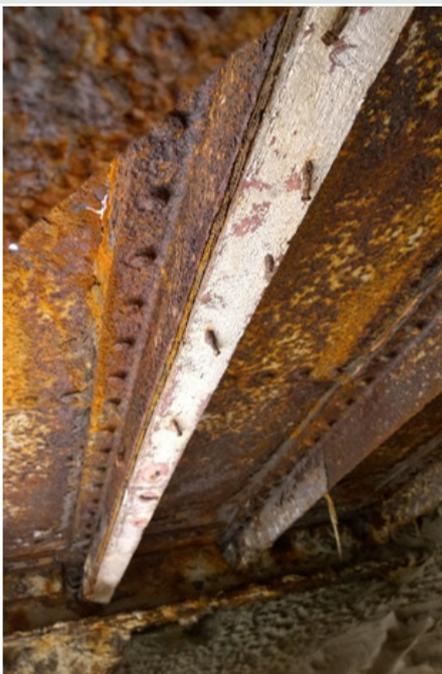
Finally, the most important damage that the wooden elements of the ship have suffered from are the metallic points with which they come in contact, but also the nails used for their joining (Figure 16). Extensive oxidation causes enormous mechanical pressures and therefore cracks and deformations, as well as coloring [14]. The wood degrades around metal because acid accumulates in the crevice where the chloride ions migrate accelerating the corrosion rate and so acid is produced. In seawater where soluble chloride salts are present the acid condition will develop quicker while at the same time, an additional reaction between iron ions and wood will be developed causing more deterioration [15-32].

**Figure 16:** Detail of wood in contact with the metal surface.
