Failure Analysis of Thermo-Mechanically Treated (TMT) Bar During Bending Operation: A Metallurgical Investigation

Souvik Das*¹, Sandip Thalukdar², Goutam Mukhopadhyay¹ and Sandip Bhattacharya¹

¹R&D and Scientific Services, Tata Steel Limited, India

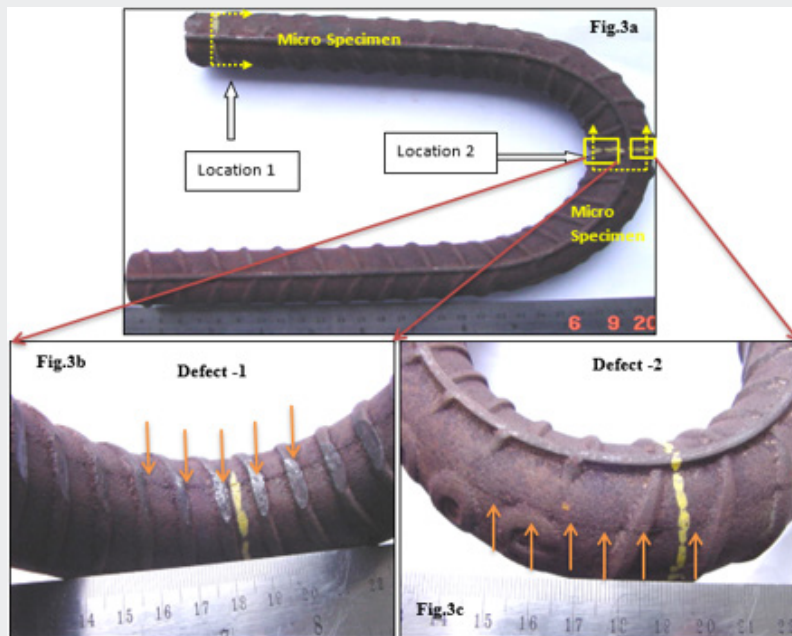
The U-bend sample was visually observed for surface defect identification. Surface defects were appeared on both side of

bend sample (compressive and tension zone) [4-5]. Appearance of defects was that, metal folded over the bent sample at an angle (Figure 2). Based on appearance, nature of defect seemed to be of lap type.

Figure 3a: Overall view of samples referred for analysis.
Figure 3b: Crack at compression zone of the rebar.
Figure 3c: Crack at tension zone of the rebar.

On visual observations of rebar sample (U-bend) longitudinal surface defects were observed in both the tension and compression zone. On appearance, metal folded over the rebar surfaces at an angle. Microstructure revealed scale entrapment in defects. Uniform rim pattern was observed in sample. The core comprised of ferrite pearlite matrix with widmanstatten microstructure; whereas at edges tempered martensite was observed. Depth of surface defect was 0.16 mm in case of location no.1; whereas 0.25 mm and 0.09 mm in case of location no.2. Depth of defects was within 1% of diameter. The above observations indicated that the defect was of lap type. Laps are discontinuities in the material which generally run more or less at an angle to the surface of the rod. They are usually quite long and of uniform shape they nearly always run longitudinally in the rod, one or more similar defects occurring uniformly distributed at the periphery of the wire rod. Sometimes, they also appear as parallel double lines.

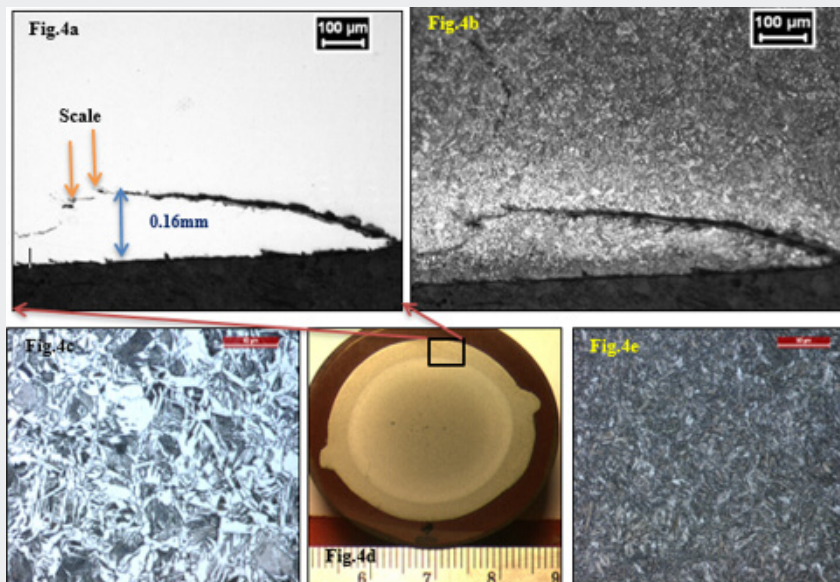
Transverse micro specimens were prepared from the locations marked in Figure 3, and studied under upright optical microscope at various magnifications. Macro dual zoom photographs of etched transverse micro specimens revealed uniform rim patterns in both the samples. Un-etched microstructure revealed inclined defects associated with scale (Figure 4a). No internal oxidation

was observed around these defects. Entrapped scale was observed at the end of defects (Figure 4b). Microstructure of all the rebar samples at edges showed tempered martensite; whereas at core ferrite pearlite microstructure along with widmanstatten pattern was observed (Figure 4c and 4e).

Figure 4a: Un-etched microstructure revealed inclined defects associated with scale.
Figure 4b: Etched microstructure revealed inclined defects associated with scale.
Figure 4c: Ferrite and pearlite in the core of the rebar sample.
Figure 4d: Macro dual zoom photographs of etched transverse micro specimens revealed uniform rim pattern.
Figure 4e: Tempered martensite in the edge of the rebar sample.

Pass overfilling is the most frequent cause of laps when material which is forced out into the roll gap folds over and is rolled into the rod surface during subsequent passes. Passes are overfilled when too large a reduction is attempted, or the wrong pass design is used. Laps can also occur when the roll passes in not adequately filled so that the lean place in the section falls over in the roll pass. Laps on only one side of the section can also due to badly aligned guide. In multi-stand continuous mills, over-filled bar ends cannot be completely avoided in the roughing passes, even with careful

The rebar failed during bending operation due to presence of surface defect. The above analysis shows that the surface defect is of lap type which was originated during hot rolling operations.

adjustment of the mill and these can cause laps. Non-uniform spread associated with severe fluctuation in rolling temperature can also give rise to lap. Laps can usually be distinguished from cracks by the typical configuration and arrangement of the defect, such as parallel double lines or discontinuities in the material distributed uniformly over section and following the circumference. It can be prevented by proper schedule changes of guides and passes, right operating practice of guide setting and alignment.
