Crack and Leakage Detection on Underground Pipelines Using Acoustic Technique

University Pertahanan Nasional Malaysia (UPNM), Malaysia

Abstract

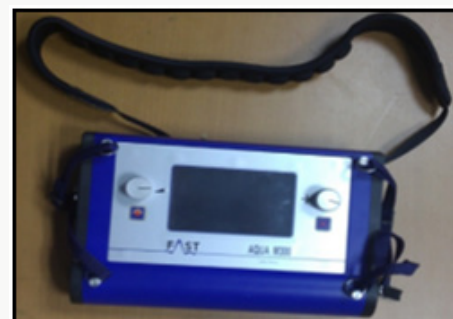
Figure 1: Acoustic Detector AQUA M300 D.

Figure 1 shows the AQUA M300 D, a multi-purpose detector designed to allow the user to carry out electro acoustic leak detection on pipe systems carrying water, acoustic leak detection on pipes, and to perform non-destructive pinpoint leak detection on pipes which have previously been flooded with trace gas using the indicative measurement of different hydrogen concentrations.

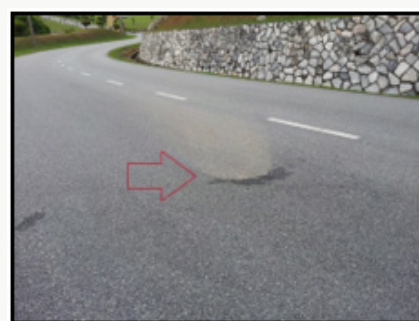
Figure 2: Watermark Detected on the Road.

Figure 2 below shows watermark appear on the road surface due to leakage or crack in underground water pipeline. Five readings have been taken to determine the sources of the leakage as shown in Figure 3 The readings are displayed in the (Table 1) From the table, it shows that frequency reading at point 4 is the highest compared to other points. The high frequency is emitted due to occurrence of underground water pipeline leakage or crack. It is resulting from the vibration that is produced by a high-pressure water flow through crevice in the water pipeline. The smart bar indicator will increase when the frequency increases. That indicates that the range of potential leakage pinpoint is narrowed down. The area that does not have water pipe shows low reading because there is no vibration occurred due to water flow.

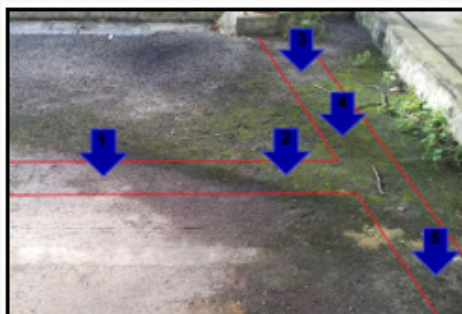
Figure 4: Wet Surface Visible at the Parking Lot Area.

A wet surface had been detected at the parking lot surface near the staffs’ residence as shown in Figure 4 The wet surface is obviously detected during peak hours. This is because during peak hours,

water consumptions are high. So, a higher-pressure force flows in the underground pipeline thus forces the water escape through the crevice. The water then is pushed up to the surface through soils and resulting in wet surface appears on the ground. The readings are taken from five pinpoints indicated by blue arrows. The red line shows the underground water pipeline path. The acoustic device has been used to determine the pinpoint of the leakage. The readings taken are plotted in Table 2. The results demonstrate that the leakage is highly possible to occur at point 4 as it shows the highest frequency reading. This is the result of vibration from water escaping from the crack or leakage on the pipe. Uniform reading should be accomplished if the pipeline is in good condition. Point 2 also shows a high frequency reading though not as high as point 4. It can be concluded that the frequency increases as the detector comes close to the source of leakage. The readings at point 1, 3, and 5 are lower compared to point 2 and 4 as they are further from the leakage pinpoint.

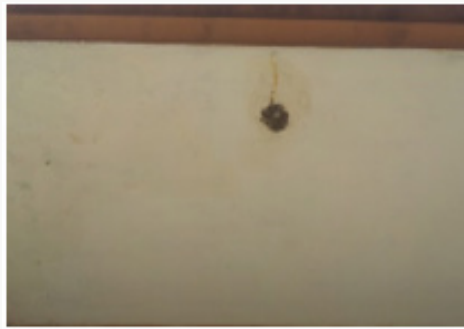
Figure 5: Watermark on the ceiling of Chancellor Building.

Watermark is detected at the ceiling of Chancellor Building as shown in Figure 5 below. Therefore, five frequency readings have been taken from five different places near the watermark as shown in Figure 6. Based on the results displayed in Table 3, there are two possible points of leakage which are at point 3 and 4. This is because at point 3 and 4, the device detected highest amplitude of loudness which came from the leakage.

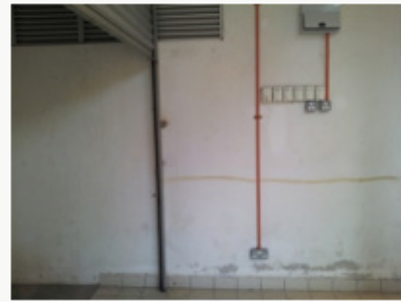
Figure 7: Watermark at Block C4

Watermark has been spotted at Block C4 as shown in Figure 7. Points of interest are labelled as shown in Figure 8 to determine the source of leakage. The results are displayed in Table 4. Based on the results, the highest frequency reading is obtained at point C followed by point B, A, and D. This is because water leakage occurred at that point causing the pipeline emitted a higher vibration that can be detected by the detector.
