# Seismic Strengthening of Masonry Buildings Using Carbon Fiber-Reinforced Polymers

The experimental study on evaluation of seismic resistance of the large-scale model of a two-story fragment of brick building from ceramic bricks on cement mortar was conducted. The dynamic testing of the prototype was carried out on the two-component vibrio plat form, where seismic impacts with the intensity of 7 to 9 according to MSK-64 scale were modelled. During the tests the constant load on floors – 4,5kH/m<sup>2</sup> was simulated using dynamic forces to the prototype were simulated. Different options for strengthening of load-bearing brick walls concrete blocks. The dimensions of the two-storey fragment are 2,3x × 1,56 × 3,0m. Using scrims from carbon fibre the slabs at each floor were combined into a single hard disk. During the tests, the horizontal and vertical with composite fabrics, scrims and nets, were considered. Upon the nature of the hysteresis curves the zones of elastic performance of masonry walls at the moment of cracks and destruction were determined. The optimal schemes of brick walls' strengthening were proposed with the use of ribbons, scrims and nets from carbon cloth. T

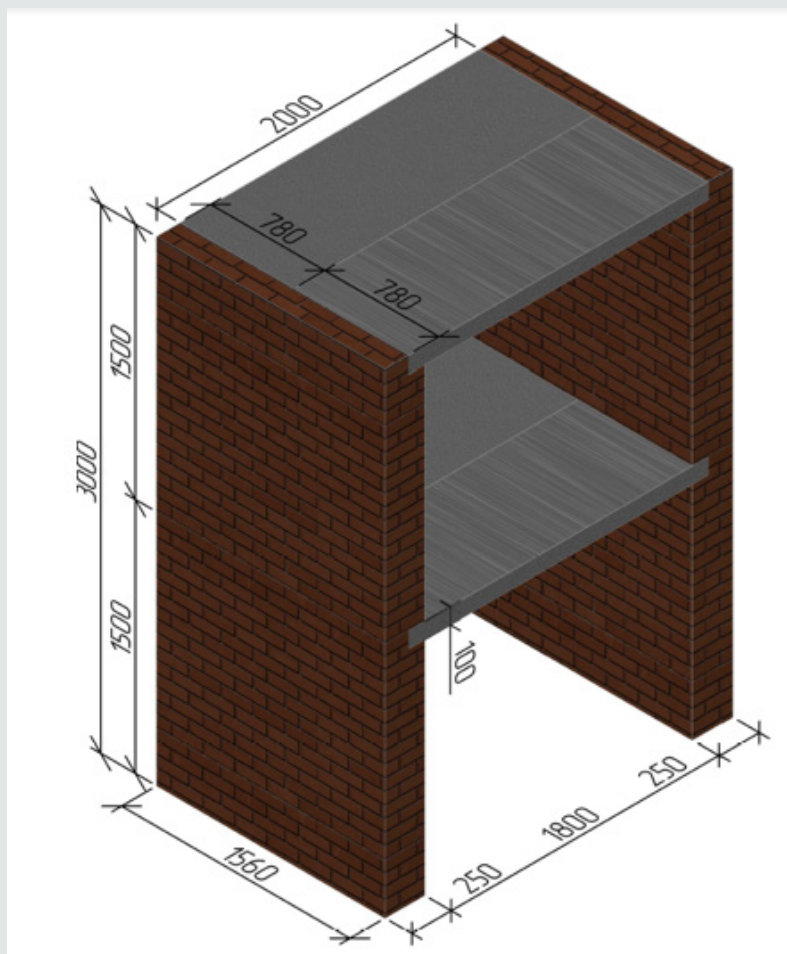
**Figure 1:** General view of experimental model building (all dimensions are in mm).

For research was mounted 2-storey fragment of the building (Figure 1). Masonry walls fragment was made of ceramic brick brand M250 on the cement solution brand M150. According to the results tests at the normal adhesion masonry corresponded to I category according to the Norms of СП 14.13330.2014 with  $R_t \geq 0,18\text{MPa}$  ( $R_t$  - the value of normal adhesion of bricks with cement mortar). To gain masonry walls were used carbon tape and carbon mesh impregnated styrene-butadien composition, as well as carbon bidirectional and multi axcial fabrics, carbon anchor bundles. Overlap 1<sup>st</sup> and 2<sup>nd</sup> floor was made of teams concrete slabs thickness of 100mm in the class of concrete compressive B20. In order to ensure collaboration plates and improve the stiffness disk ceiling in his plane plates were combined with cross ties of carbon tapes. As a load on the plate overlap 1<sup>st</sup> and 2<sup>nd</sup> floor was mounted loads mass 300kg. Figure 2 shows a general view of experimental sample set on the vibro platform. Taking into account own weight plates distributed load on the overlap in the level of each floor was  $4.5\text{kH/m}^2$ . To measure the dynamic parameters impact on the structure and directly dynamic characteristics of the fragment was used instrumentation, installed on the structures and vibro platform (Figure 3).

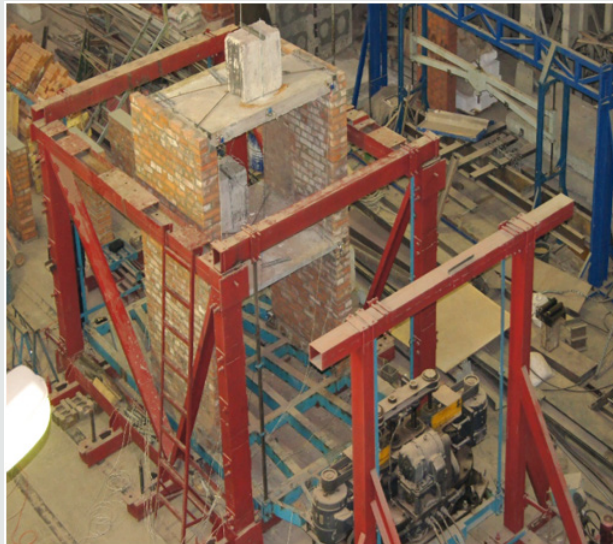
Figure 2: General view 2-storey fragment building on the vibrio platform before strengthening.

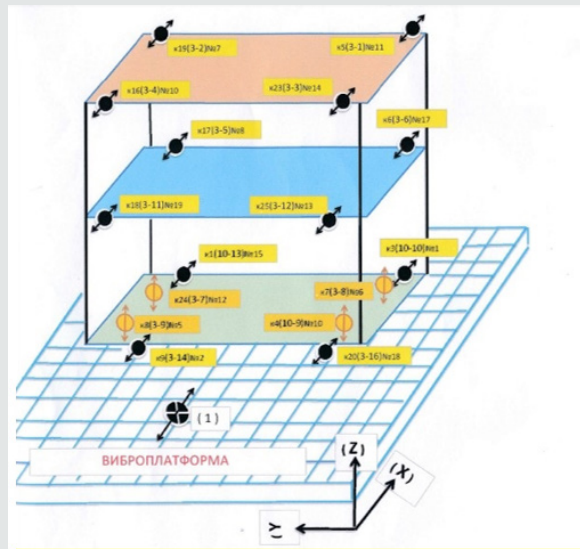
Figure 3: Scheme location devices on the sample.

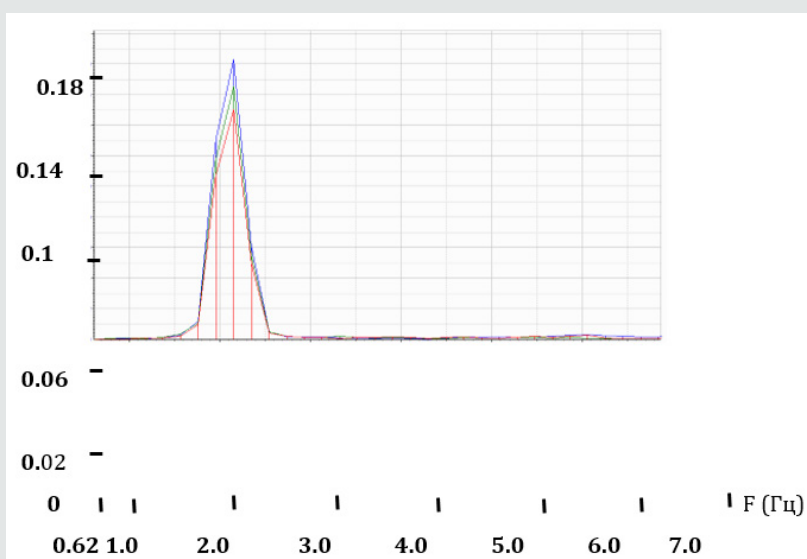
Figure 4: Spectra of oscillation acceleration (loading mode number 1).

**Analysis of the results of the first stage of the test:** The results of processing records acceleration of oscillations points on the structures of the building fragment when tested in the specified above the frequency range are presented in the form of

graphs (Figure 4). These graphs show the range of acceleration fluctuations in the level 3 (Blue), the level 2 (Green) and in the level 1 (Red) during the test of the fragment in loading regime № 1. In the process of tests at the horizontal acceleration platform  $0,782\text{m/s}^2$  and frequency of 3,8Hz (mode loading № 7), which corresponds to seismic effects of 7 points on the scale MSK-64, there have been cracks in one of the brick walls. Before the appearance of cracks design was represented by a monolithic system, and the schedule of the curves had a view shown in Figure 5a. With further increase in the load, there has been a destruction of compressed support area masonry of one of the walls and appearance of horizontal cracks on the seam (stretching masonry). At the time of the crack appearance hysteresis curve had a type of shown in Figure 5b, i.e., to further increase in dynamic load would lead to complete destruction of the system.

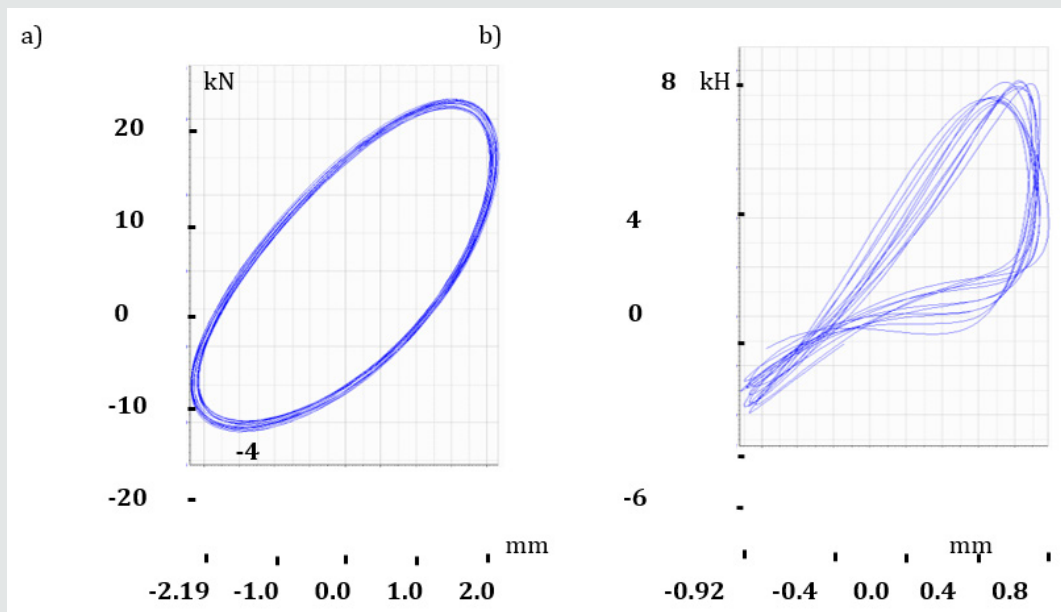
Figure 5: (a) General view of hysteresis curve before the destruction of masonry (b) and in the process of cracks appearing.

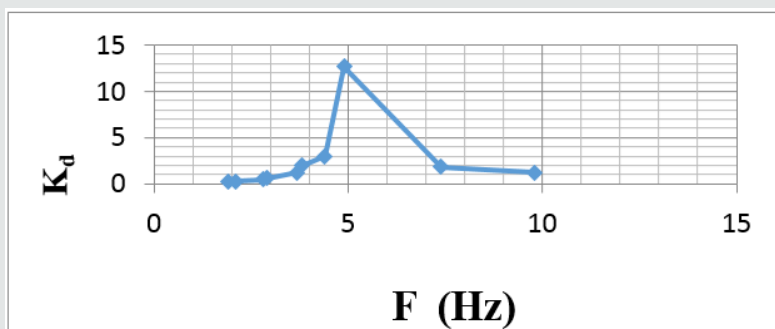
**Figure 6:** The value of the coefficient of dynamic the 2<sup>nd</sup> floor). Figure 7 shows the nature of 2-storey fragment strengthening with external reinforcement by carbon fabric.

The graph of the Figure 6 shows the dependence of the coefficient of dynamic for relative fluctuations in the upper floors fragment on platform oscillation frequency. The values of the

coefficient on the frequencies of 7,4 and 9,8 Hz have been obtained as a result of the spectral analysis of earlier indicated oscillations.

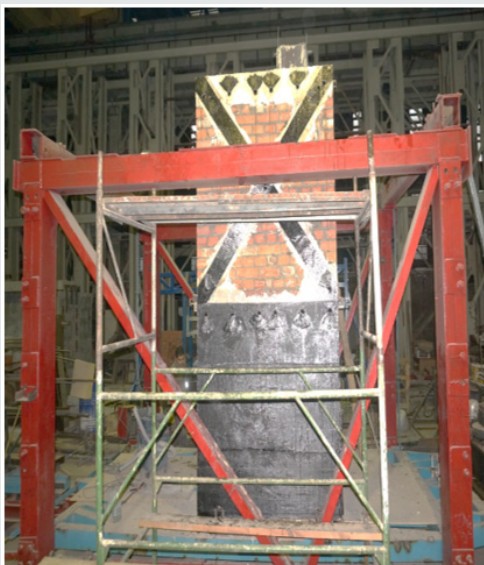
**Figure 7:** General view of the reinforced sample on the second stage of the test.

**Prior to the second stage of tests the following work on the strengthening of structures has been done:**

a) Masonry was restored and reinforced with concreting to provide a joint work of masonry support area with the basis.

b) Strengthening of masonry walls was provided in the level 1<sup>st</sup> and 2<sup>nd</sup> floor with the use of bi-directional carbon fabric (in the level of the 1<sup>st</sup> floor) and carbon tapes width 300mm (in the level after installation of external reinforcement in the level of overlapping 1<sup>st</sup> and 2<sup>nd</sup> floor anchor bundles were installed to provide Mounting of the external reinforcement elements into masonry of the walls.

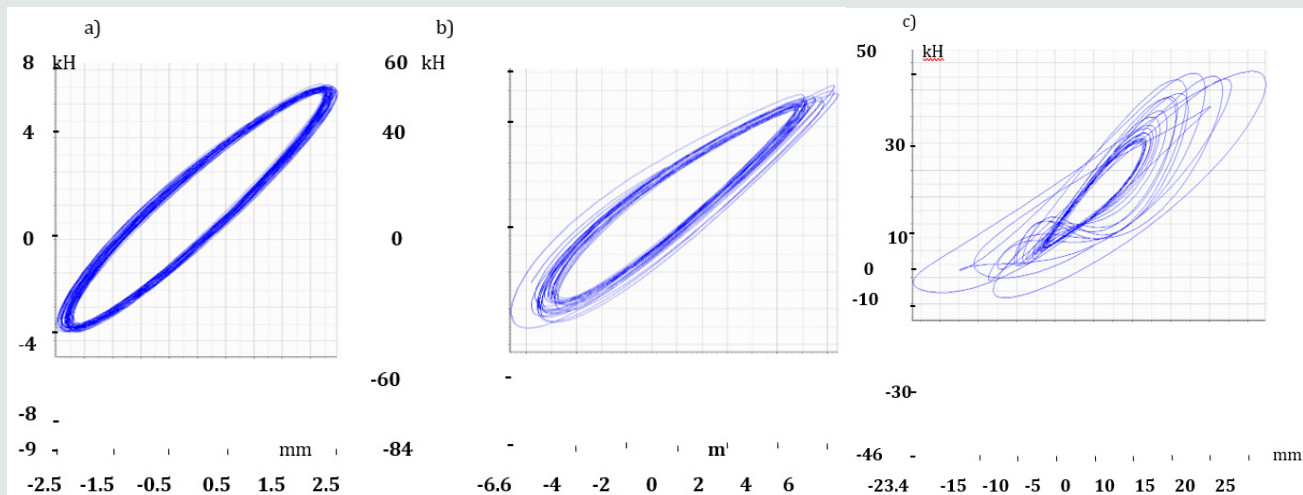
**Figure 8:** General view of hysteresis curve in moments: elastic work of the construction (a), at the time of the appearance of the longitudinal cracks in the level of the bottom of the overlap 1st floor (b) and after its appearance (c).

When the levels of dynamic loading are small, and the construction works in the elastic stage hysteresis curves at different levels of loading do not have shift on the horizontal and vertical axis (Figure 8a). At the moment, close to the emergence of cracks in the structures, hysteresis curves take the form shown in Figure 8b. At the time of the destruction of moving in different points of

the sample are different: the construction starts working not as a monolithic system, but as a system consisting of the individual sites (the construction “is in the spacing”), and hysteresis curve becomes as shown in Figure 8c. The horizontal acceleration platform 1,9m/s<sup>2</sup> and frequency of 5,0Hz began the process of horizontal cracks appearing in interface walls of the 1<sup>st</sup> and 2<sup>nd</sup> floors in the level of overlap 1st floor. The future changes in the load horizontal crack spread all over the length of the Wall. At the same time vertical deformation of masonry in the zone contact the walls of 1<sup>st</sup> and 2<sup>nd</sup> floor changed from negative values (compression) on one edge of the Wall to positive values (stretching) - by other side of its edge. As analysis showed the nature of cracks formation in the masonry walls of 2-storey fragment, the lack of relations between the elements of strengthening of the 1<sup>st</sup> and 2<sup>nd</sup> floor (there was no interlace of tapes and fabric) led to the appearance of the horizontal cracks in contact the walls of 1<sup>st</sup> and 2<sup>nd</sup> floor. On the third stage of the test fabric of carbon fibers in the level of the first floor was replaced on carbon grid with additional installation of vertical tapes width 300mm (Figure 9), which are located continuously along the height of the fragment.

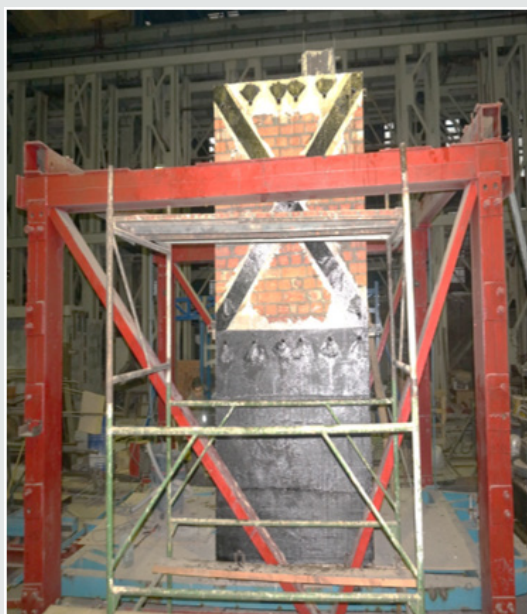
**Figure 9:** General view of the enhanced sample on 3 stage test.

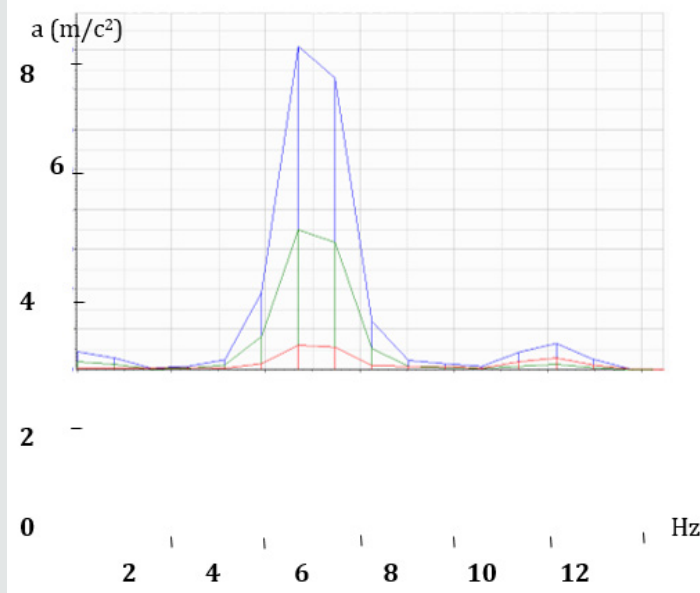
Figure 10: Spectra of oscillation acceleration (loading mode number 8).

In Figure 10 shows the Spectra of acceleration fluctuations in the level 3 (Blue), the level of 2 (Green) and in the level 1 (Red) during the test fragment in the mode of loading number 8. During

the process of test 28 modes of dynamic loading system with changes in the frequency spectrum of 1,3 to 4,7Hz was performed. The amplitude of oscillations platform changed in the range from 0.8 to 21mm. Vibration amplitude of the top of the experimental sample was changed in the range from 2,0 to 34,7mm. Acceleration maximum value of the vibro platform was  $6,5\text{m/s}^2$  that was more than one and a half times of the standard value of acceleration for the site with range 9. at the same time acceleration at the top point of 2-storey fragment (plate overlap over the 2nd floor) at the moment, close to the destruction of masonry, changed from  $6,5\text{m/s}^2$  (23<sup>rd</sup> mode loading) to  $13,6\text{m/s}^2$  (the time of the destruction of masonry - 28<sup>th</sup> loading mode). During the 23<sup>rd</sup> loading mode there was the beginning of the destruction of boundary-value sites of masonry near the support zone (Figure 11). At the moment, close to the destruction, there was a crushing brick in the corner areas of the walls in the level of supporting on vibro platform, that. ie. in

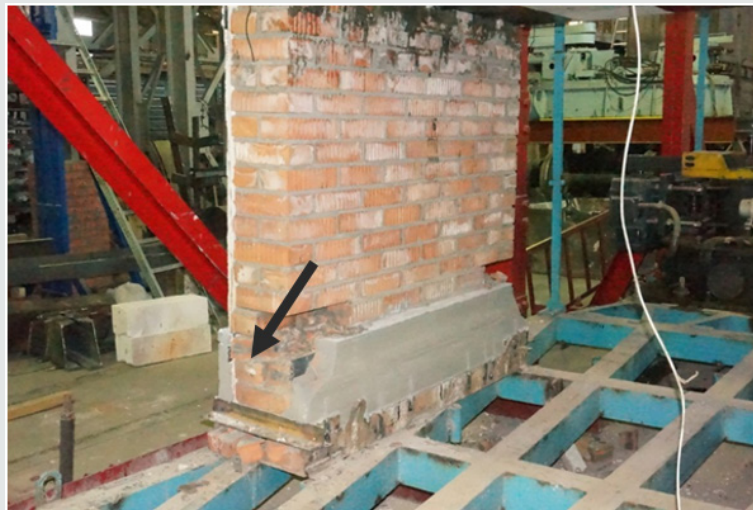
Figure 11: The nature of the destruction of the brick wall support area.

areas with maximum stress compression of masonry. At the same time because of the cyclic changes of the load sign the process of destruction included masonry bundle followed by its crumpling. As seen on Figure 11, the presence of external reinforcement from the outer side of the walls of the as seen on Figure 11, the presence

of external reinforcement from the outer side of the walls of the building fragment excluded masonry uniform compression on the thickness of the Wall. In this case the maximum voltage compression took place inside the corner zone of the walls.
