ECG Rhythm Disturbances or Artefacts-Unusual Cause as Culprit

Case Report

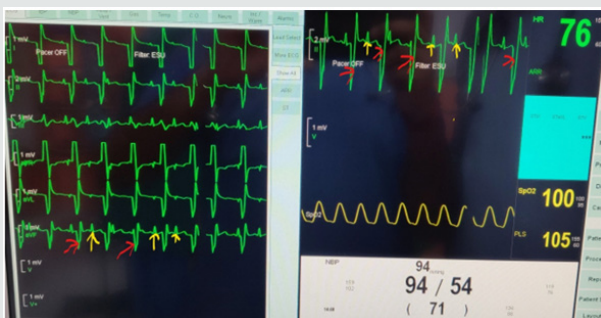
Figure 1: The ECG showed broad QRS complex and changes mimicking that of bundle branch block.

In this case, the patients's warming system that was Geratherm warming system, had caused electrical interference in the ECG, mimicking serious ECG changes. Our operation theatres have complete grounding electric and earthing system to minimize electrical interference despite which the warming system produced the changes in the ECG [1]. In an operating room environment, the patient is likely to be monitored by more than one device showing the heart rate and rhythm- the plethysmograph, the direct arterial blood pressure monitor and the CVP monitor. In the event of a true arrhythmia, changes in the rate and rhythm are likely to show up in all the monitors and not just the ECG. The presence of a normal plethysmograph during the electrocardiographic changes should arouse the suspicion that the changes are not pathologic. Also, pseudo arrhythmias are not responsive to the treatment given for the arrhythmia that they mimic. This lack of response to treatment, if administered, points towards the changes in the

electrocardiogram being artefacts. The reversal to sinus rhythm on removal of the suspected source of the artefacts also indicates the absence of a pathology.
